**ACITYA WISESA (Journal of Multidisciplinary Research)**

Vol. 2, Issue. 3 (2023)

## **Performance of Boom Cylinder Repair Mechanism and Auto Lubrication System of EX 2500 Hitachi Excavator**

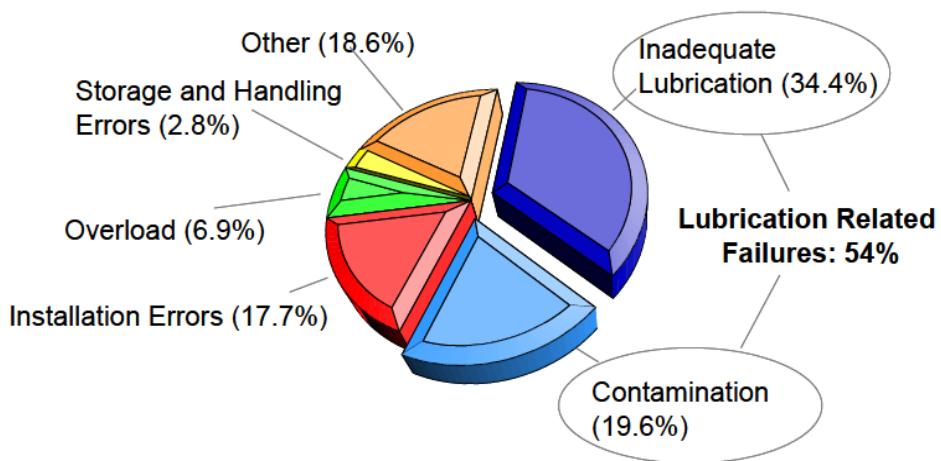
**Figure 1.** Component Major Damage Tabulation

According to a factory-conducted study at a major component manufacturer, it was reported that more than 50% of machine failures on excavators were caused by improper lubrication, or the inappropriate type of lubricant (hydraulic oil and grease) used on the machine and contamination that entered into the hydraulic system.

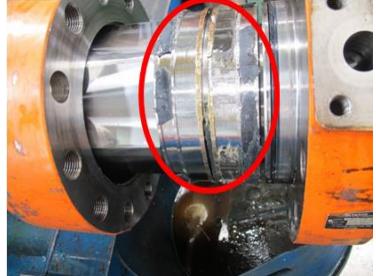
No.	Damage	Damaged Component	Cause	Picture
1.	Internal Leak	Ring Seal Slide Ring O-Ring	Scratch Contamination Overheat

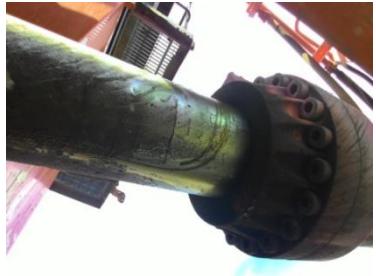
2.	External Leak	U-ring Ring Back Up Seal Dust O-ring	Scratch Contamination Overheat

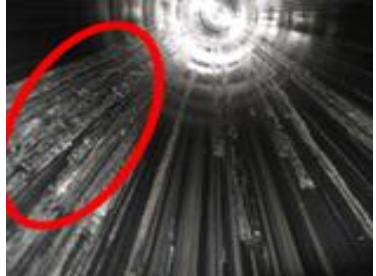
3.	Scratch	Cylinder rod Cylinder tube Cylinder Head Piston rod	Contamination

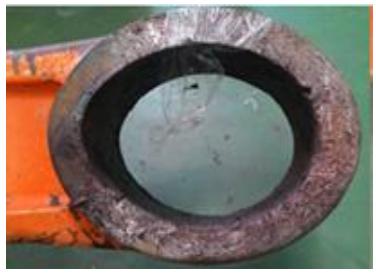
4.	Wear	Eye tube Eye rod Pin Bushing	Auto lubrication does not function properly

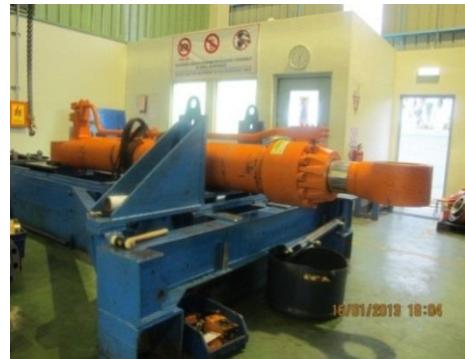
**Figure 2.** Boom Cylinder Benchwork

- a. Place the boom cylinder on the benchwork.

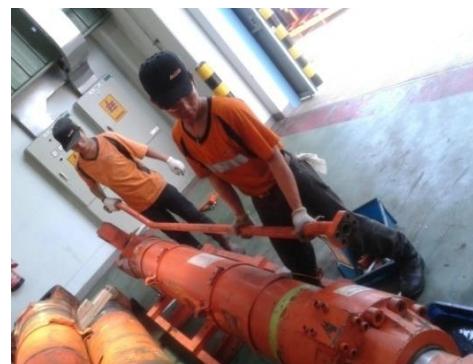
**Figure 3.** Boom Cylinder Piping

- b. Remove all accessories attached to the cylinder, such as pipes, joint blocks, and slow return valves.

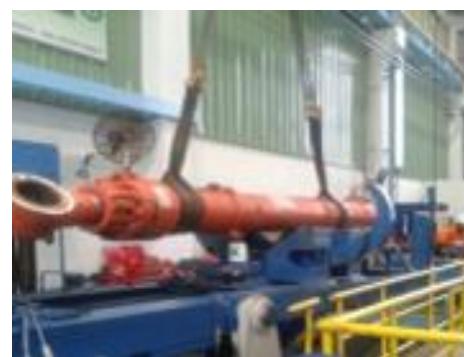
**Figure 4.** Lifting Boom Cylinder

- c. Move the boom cylinder to the rotary cylinder bench machine to facilitate rod removal with the overhead crane.

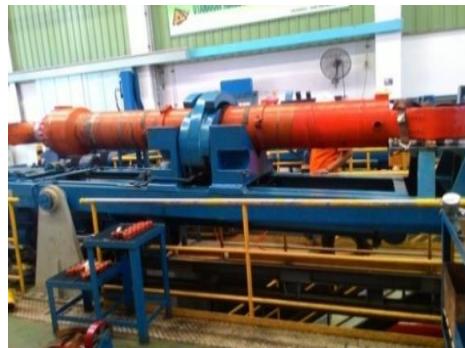
**Figure 5.** Rotary Cylinder Benchwork

- d. Attach a clamp to the boom cylinder and tie the eye tube to prevent it from falling when positioned vertically.

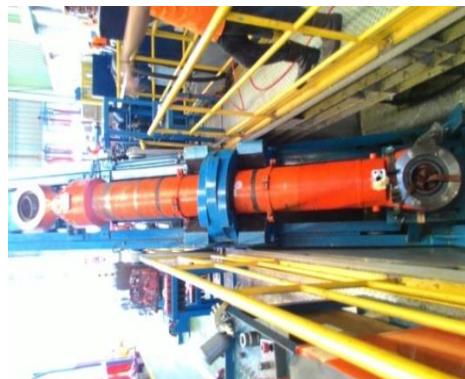
**Figure 6.** Boom Cylinder Positioned Vertically

- e. Position the boom cylinder from horizontal to vertical with the rotary cylinder bench machine.

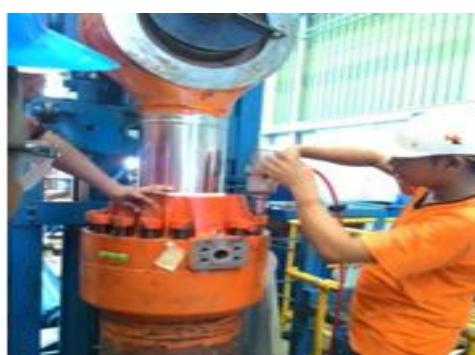
**Figure 7.** Removing The Cylinder Head Bolts

- f. Remove the cylinder head bolts using hydrolic torque or impact gun. Leave two bolts unremoved so that when the cylinder rod is removed, the cylinder head does not come off near the eye rod.

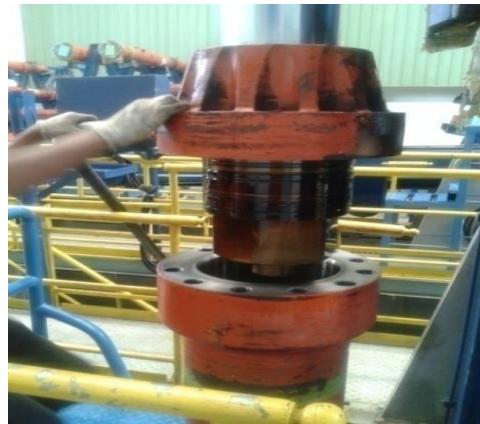
**Figure 8.** Disassembling the Cylindrical Boom  
Source: Personal Documentation of Researchers

- g. When fully extended, remove the two remaining bolts so that the cylinder tube and rod can be separated during the inspection and measurement process.

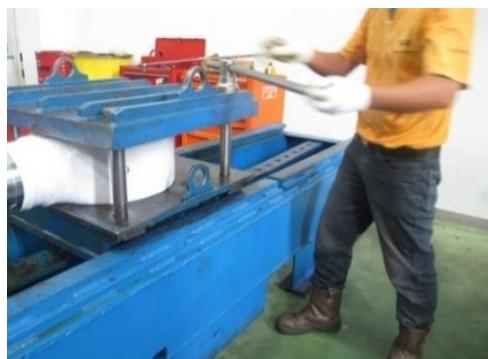
**Figure 9.** Fastener Table  
Source: Personal Documentation of Researchers

- h. Move the cylinder rod to the workbench. Tie the eye rod using the fastener table to clamp the rod so that the rod does not rotate when the piston nut is loosened.

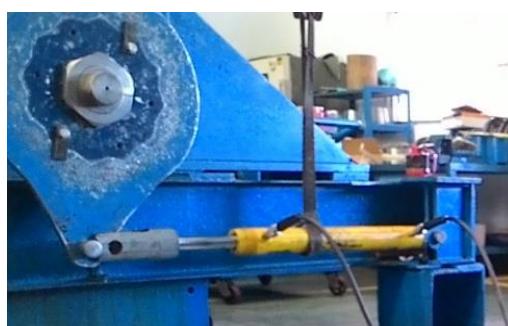
**Figure 10.** Special Tools  
Source: Personal Documentation of Researchers

- i. Loosen the piston nut with the hydraulic piston and energpac.

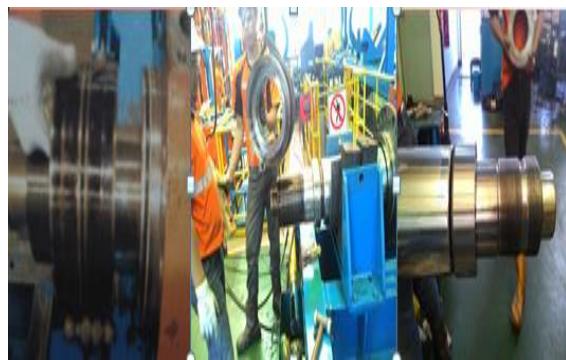
**Figure 11.** Disassembling the Piston

- j. Remove the piston slowly by hand. Then, lift the piston with a crane, as well as the cushion bearing.

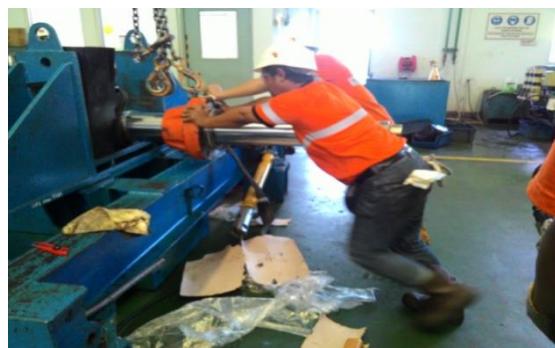
**Figure 12.** Disassembling the Head Cylinder

- k. Position the cylinder head to the end of the rod to make it easier to remove from the rod using a crane.

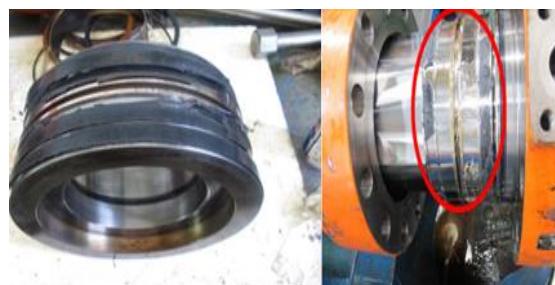
**Figure 13.** Piston Inspection

Check the condition of the piston surface, piston groove surface and seal group seat (seal ring, ring slide, o-ring) for corrosion or scratches.

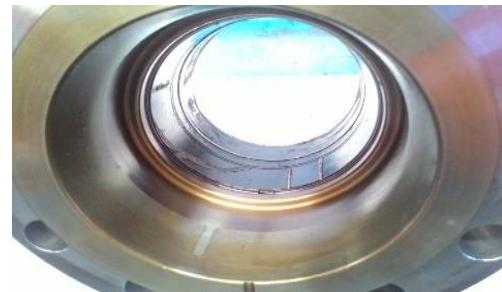
**Figure 14.** Inspecting the Cylinder Head

Open and check the surface of the cylinder head and seal group (retaining ring, u-ring, back-up ring, o-ring and dust seal) and the seats. Make sure there is no scratch.

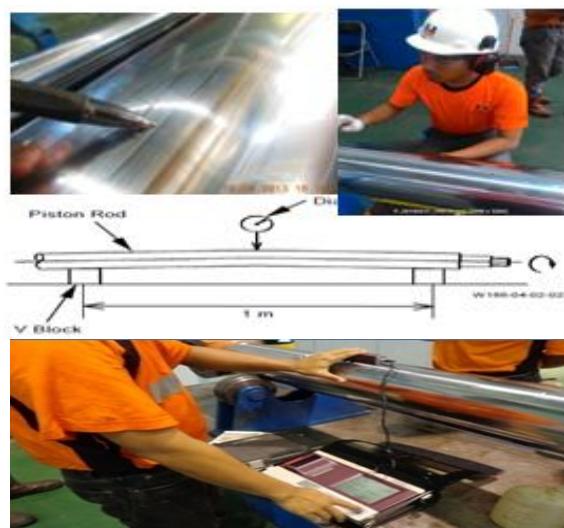
**Figure 15.** Cylinder Rod Inspection

- 1) Measuring run out or bend using a dial indicator (max 0.05 mm).
- 2) Measuring cylinder rod diameter and roughness using roughness tool (0,05 – 0,1 $\mu$ m).
- 3) Measuring chrome thickness using thickness tool (30 $\mu$ m-200 $\mu$ m).

Backhoe					
	Boom		Arm		Bucket	
	Cylinder Tube Inner Dia (A)	310 $^{+0.081}_{-0.003}$	12.2 $^{+0.0}_{-0.003}$	280 $^{+0.0}_{-0.081}$	11 $^{+0.0}_{-0.003}$	230 $^{+0.0}_{-0.072}$
Rod Dimensions (C) After	230 $^{+0.015}_{-0.025}$	9 $^{+0.0}_{-0.001}$	210 $^{+0.015}_{-0.035}$	8.3 $^{+0.001}_{-0.001}$	170 $^{+0.014}_{-0.032}$	6.7 $^{+0.001}_{-0.001}$

tolerance on the cylinder rod is 0.05 mm. Damage to the boom cylinder can cause long unit downtime, huge maintenance costs, and the potential for work accidents.

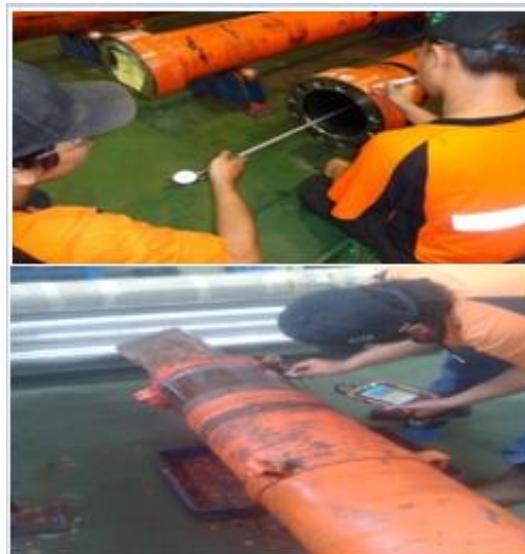
**Figure 16.** Cylinder Tube Inspection

- 1) Measuring the inner diameter at three points, each point three times measuring in the direction of the axis (x,y,z) using a bore gauge (Standard:  $280 \pm 0,080$  reman limit:  $280 \pm 0,120$ mm).
- 2) Measuring the thickness of chrome cylinder tube (standard:  $30-200\mu\text{m}$ ).

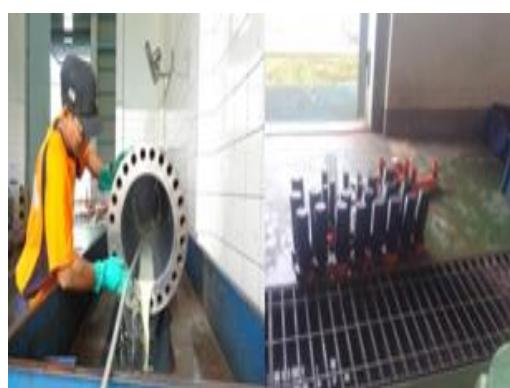
**Figure 17.** Cleaning and Washing

Clean all boom cylinder components, such as cylinder tube, cylinder rod, piston, cylinder head, slow return valve and bolts.

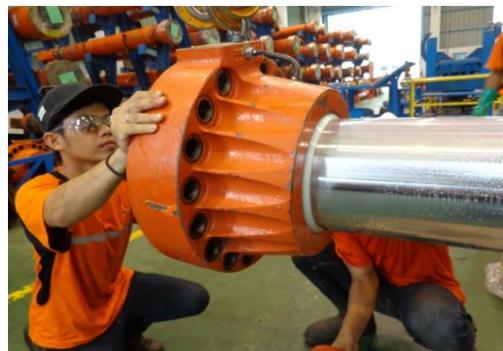
**Figure 18.** Assembling Cylinder Seal Head

- a. Cylinder Head
  - 1) Install ring retaining.
  - 2) Install O-ring and ring back up, then grease.
  - 3) Install U-ring dan ring back up (heated to 700°C for 30 minutes).
  - 4) Install dust seal dust using special tools hydrolic pressure.

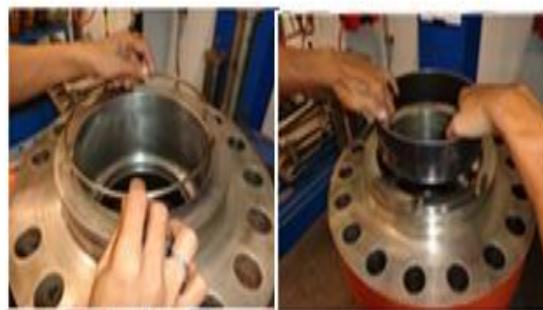
**Figure 19.** Assembling Piston Seals

- 1) Install seal group (O-ring and ring back up). Lubricate with grease.
- 2) Install o-rings and piston seals on the outside using special tools.
- 3) Install slide ring.
- 4) Install the outer O-ring using special tools. Lubricate with grease.

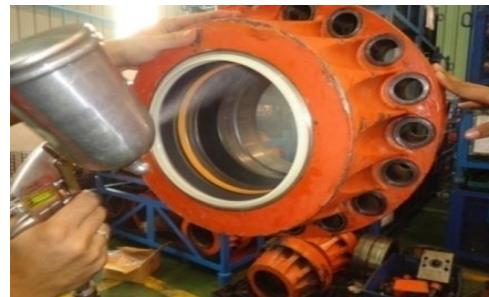
**Figure 20.** Spraying Chemical Liquid

- 1) Place the cylinder rod on the benchwork.
- 2) Spray chemical liquid on the cylinder rod and cylinder head.

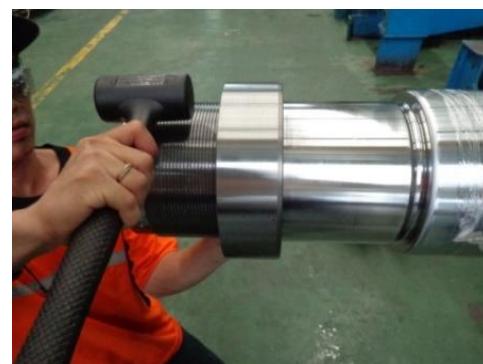
**Figure 21.** Installing Cylinder Head

- 3) Install the cylinder head.

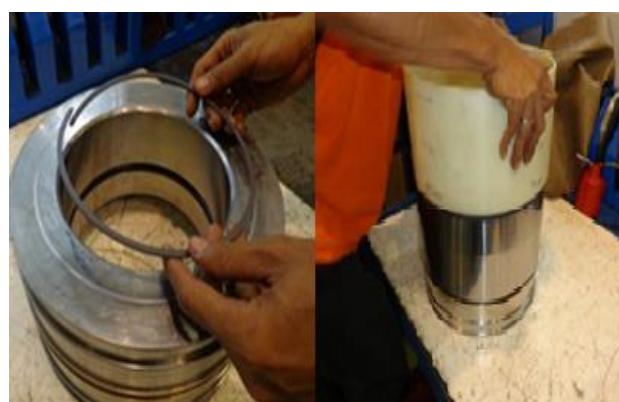
**Figure 22.** Installing Cushion Bearing

- 4) Install the cushion bearing with a rubber mallet.

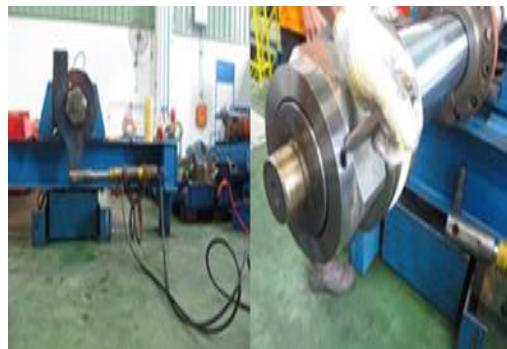
**Figure 23.** Installing Piston

- 5) Install the piston with a rubber mallet. Cover the o-ring and slide ring with insulating paper.

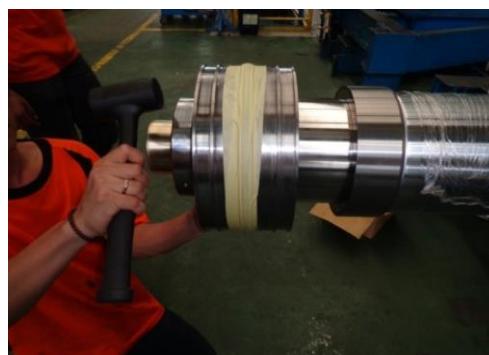
**Figure 24.** Tightening the Nut

- 6) Install the nut using special tools and a hydraulics jack.

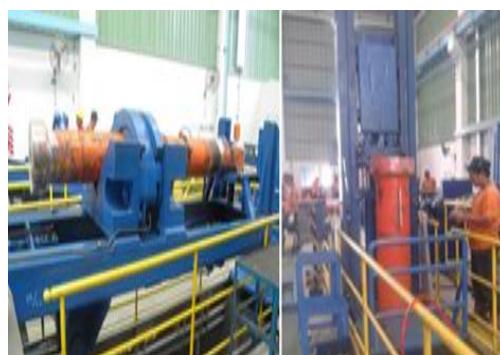
**Figure 25.** Rotary Benchwork

- 1) Place the boom cylinder on the rotary bench work, lock it with a clamp, then position the boom cylinder vertically.

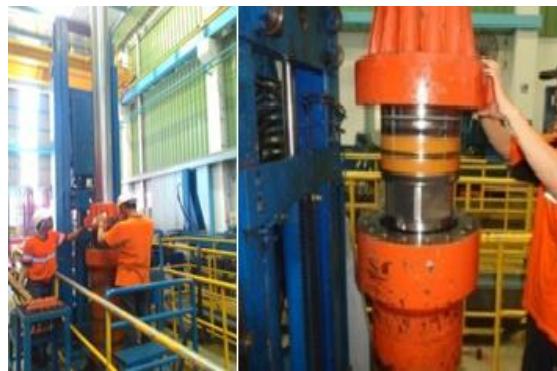
**Figure 26.** Assembling Boom Cylinder

- 2) Assembly cylinder tube with cylinder rod. Do it carefully to avoid scratches on the cylinder tube.

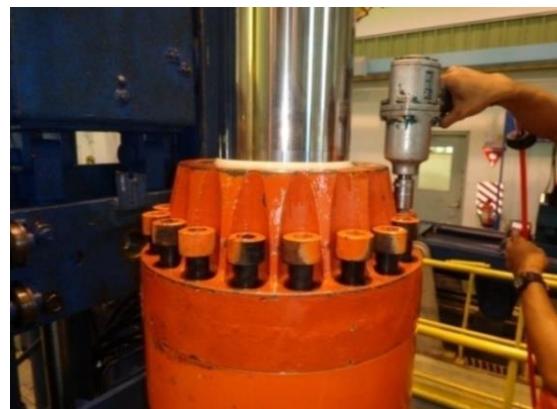
**Figure 27.** Tightening the Cylinder Head Bolts

- 3) Install all bolts using an impact gun or hydraulic torque.

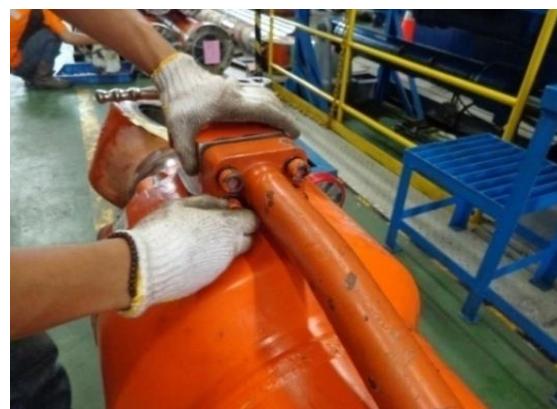
**Figure 28.** Assembling the Slow Return Valve

- 4) Assembly the slow return valve and the pipe.

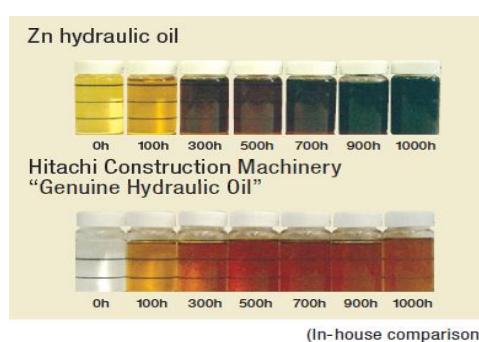
**Figure 30.** Life Time Comparison of Hitachi Hydraulic

- Hitachi Oil contains good oxidation stability to extend component lifetime. Tests conducted by Hitachi to compare Hitachi Oil products with other brands have concluded that Hitachi Oil has high oxidation stability, making sludge less likely to occur. Sludge can interfere with and cause damage to the oil filter. In addition, sludge can also cause scratches on components that grind against each other, such as piston rod and cylinder tube.

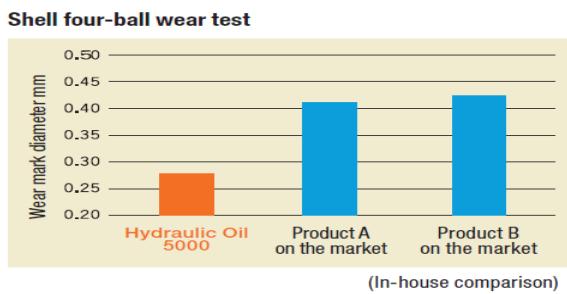
**Figure 31.** Diagram of Testing for Wear

- b. According to the results of the four-ball wear shell test, Hitachi Genuine Oil 5000 has high frictional resistance and is effective in reducing wear on hydraulic components.

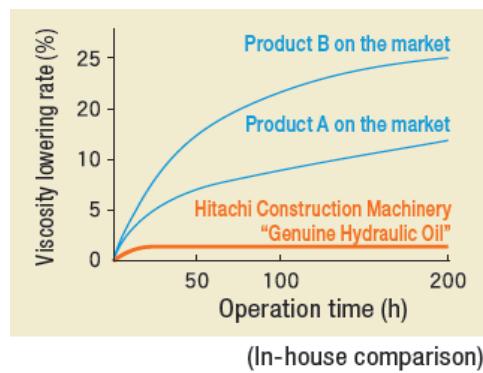
**Figure 32.** Viscosity Testing Chart

- c. Hitachi Genuine Hydrolic Oil 46TP has good shear force stability so that it can reduce viscosity changes even if the engine or component is operated and does not perform oil changes on time.

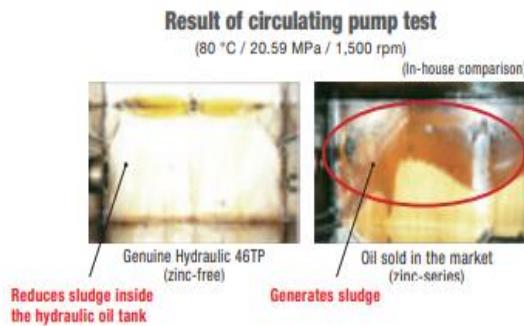
**Figure 33.** Sludging in the Hydraulic Tank

- d. Hitachi Genuine Hydrolic Oil 46TP is a Zinc-free hydraulic oil. Zinc can improve the lubrication performance. However, when Zinc reacts with sulfur elements, it will produce sludge. Sludge can interfere with the hydraulic system because it can cause damage to the seal and even the pump. In addition, sludge will also increase wear on components that rub against each other, such as pumps, boom cylinders (pistons with cylinder tubes) and others. Therefore, testing was carried out, where Hitachi Genuine Hydraulic Oil 46TP only contained a small amount of sludge in the hydraulic tank when compared to hydraulic oil containing Zinc.

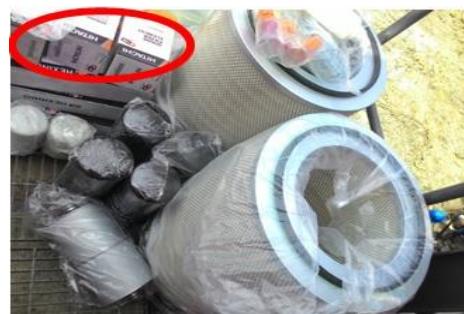
**Figure 34.** Hydraulic Oil Filter

In hydraulic systems, the cleanliness of hydraulic oil is the most important thing that must be maintained. Grams or metal debris in hydraulic oil can damage the components of hydraulic components that friction each other so that scratches can occur, which may lead to internal leaks. To overcome this problem, a hydraulic oil filter change should be conducted every 500 hours.
